Commission Meeting - February 27, 2017

Vulnerability
Analysis

FDEO Coastal Vulnerability Assessment

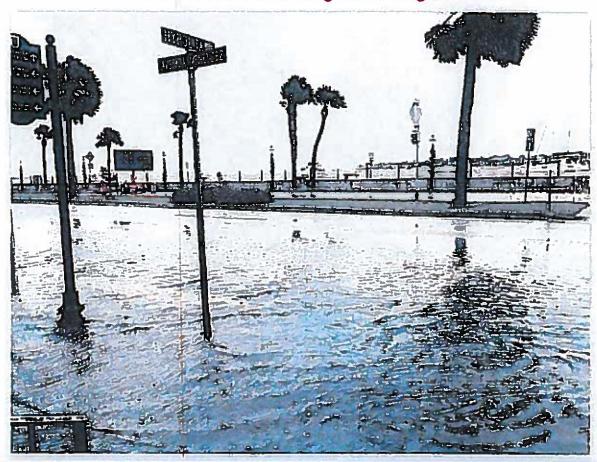
Common Tidal Flooding in St. Augustine

Photos taken in October 2014 during a Nor'easter

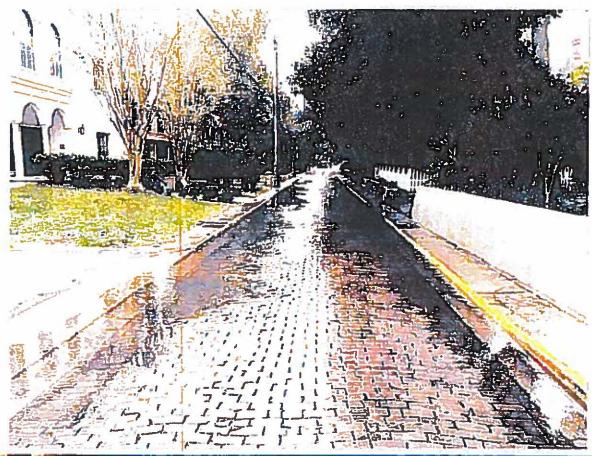
Common Tidal Flooding in St. Augustine

Photos taken in October 2014 during a Nor'easter

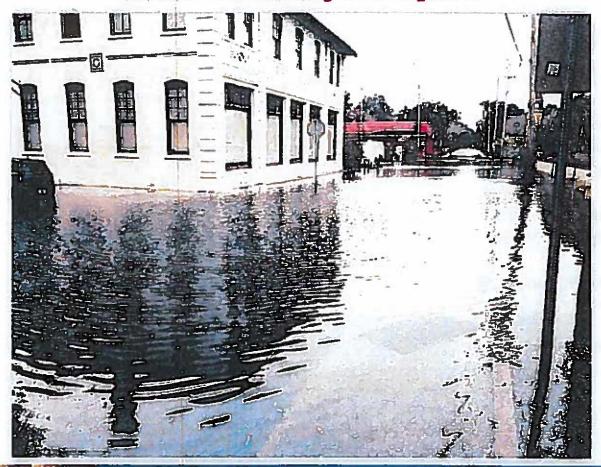
Common Tidal Flooding in St. Augustine

Photos taken in October 2014 during a Nor'easter

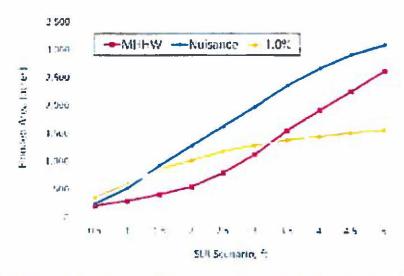
Used three flood hazard types for assessment (NAVD88):

- Mean Higher High Water (MHHW) @ 2-ft
- Nuisance Flooding @ 3.75-ft
- 1% Flood @ 6-10-ft

Figure 2. Changes in flooded orea by flood type. Note rapid growth of nuisance flood areas, which is shared by MHHW after 2 ft of SLR. The 1% annual chance floodplain experiences slow growth after 1.5 ft of SLR.

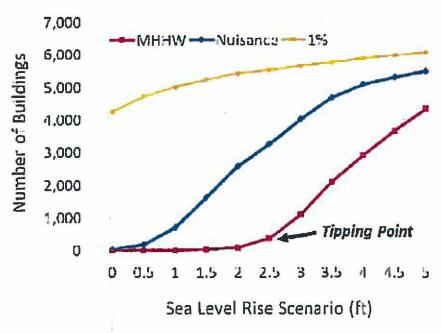
Figure 14. Number of buildings (commercial, residential and municipal) affected by MHHW, nuisance, and the 1% flood level in each SLR scenario.

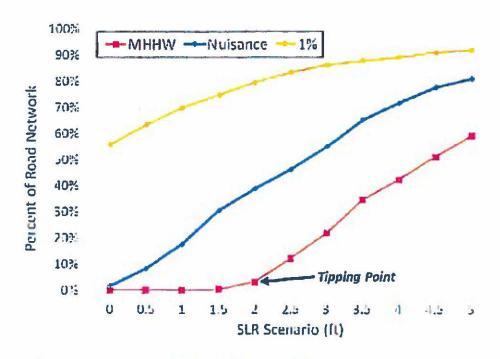
Figure 9. Percent of road network affected by MHHW, nuisance, and the 1% flood level for each SLR increment.
